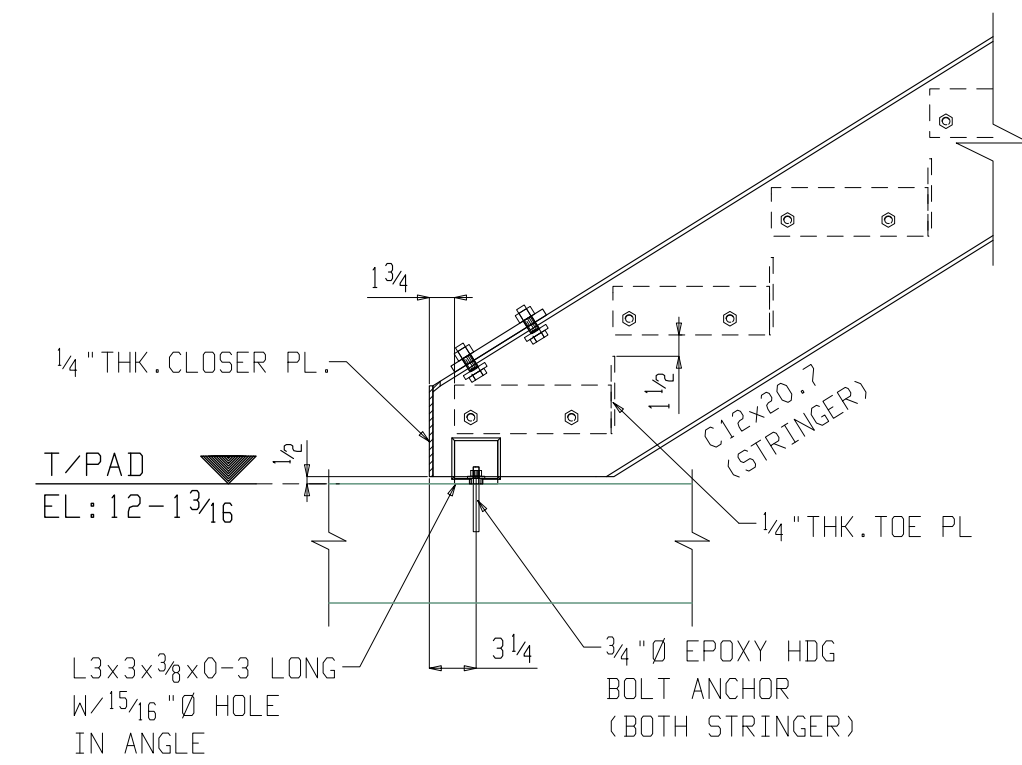
1  
E3  
DETAIL VIEW  
(REF.DRW. A/A58)  
(HANDRAIL NOT SHOW FOR CLARITY)

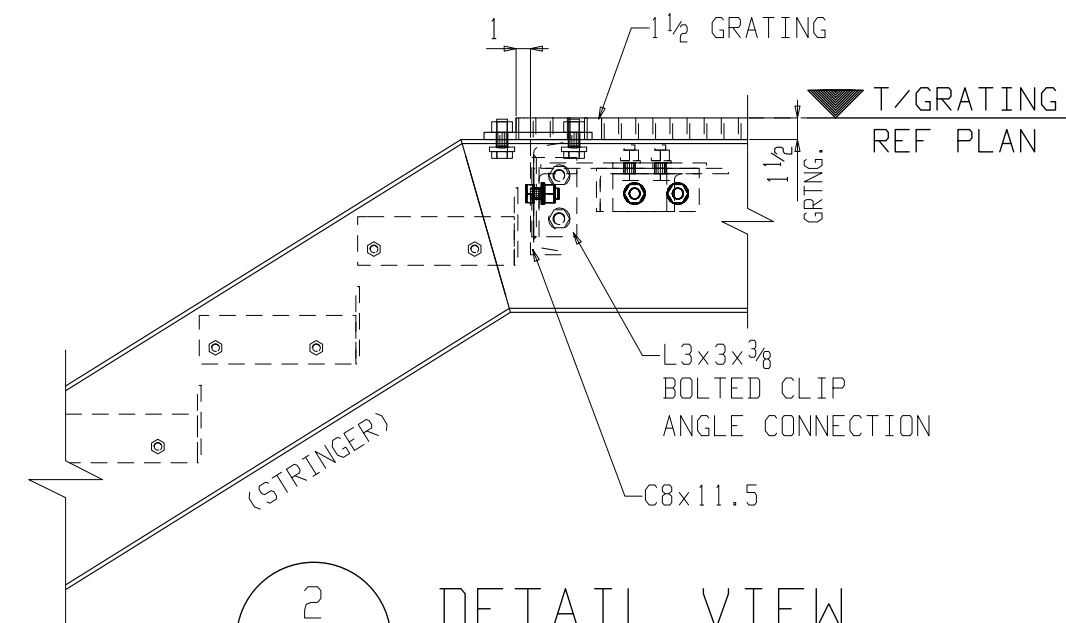
2  
E2  
DETAIL VIEW  
(REF.DRW. B/A58)  
(HANDRAIL NOT SHOW FOR CLARITY)

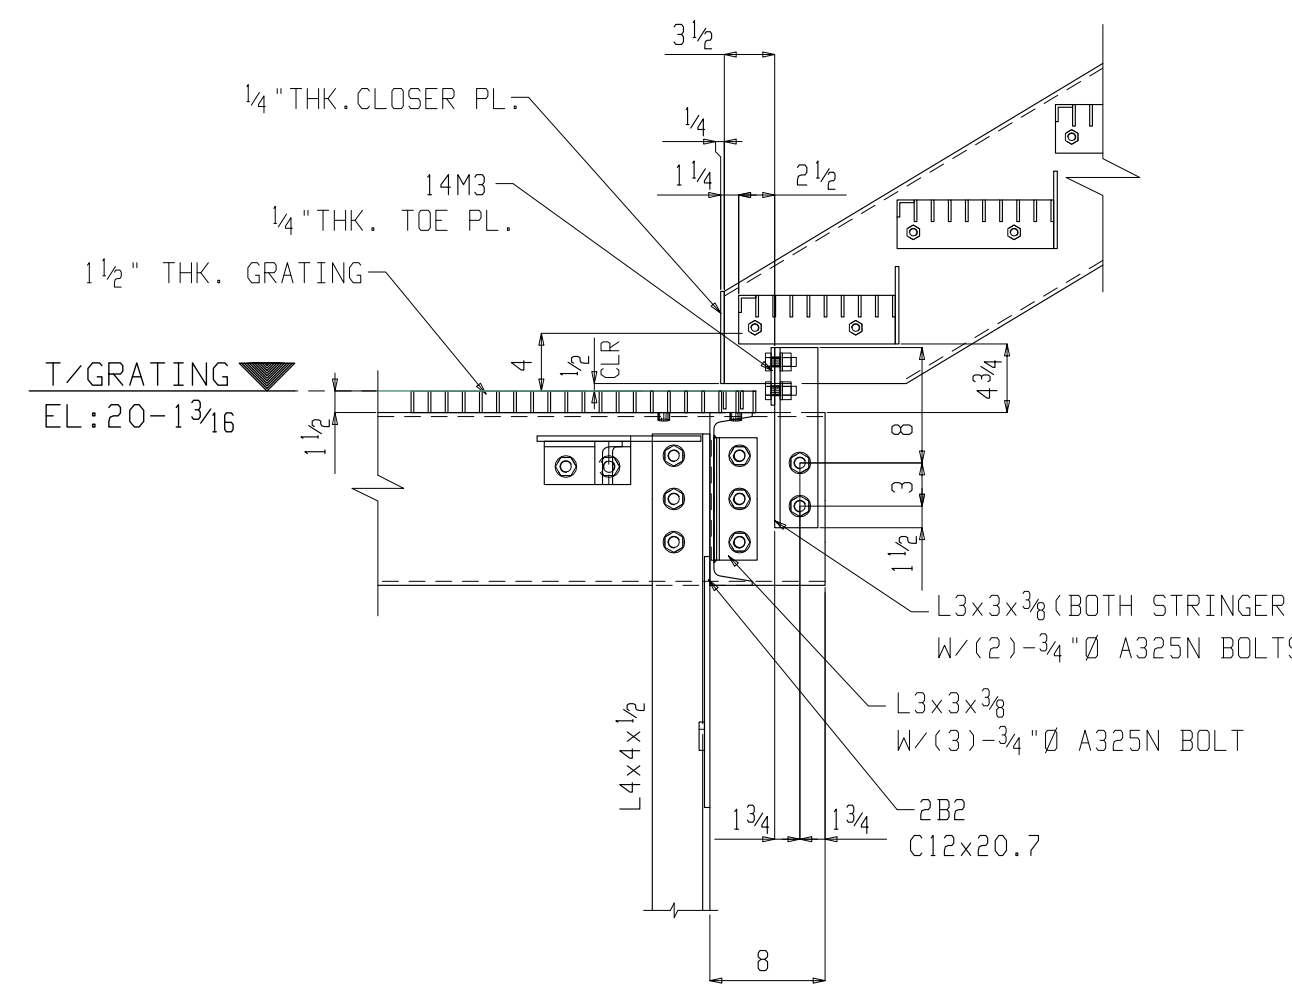
3  
E3  
SECTION VIEW  
(REF.DRW. C/A58)  
(HANDRAIL NOT SHOW FOR CLARITY)

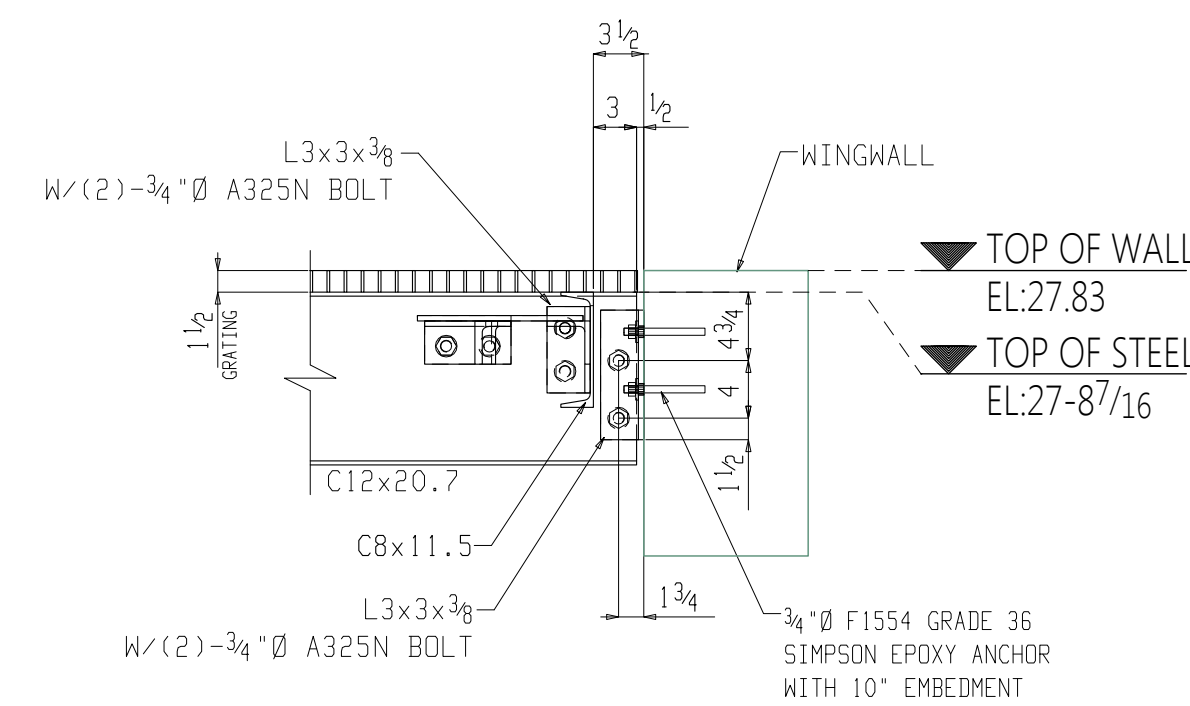
4  
E3  
SECTION VIEW  
(REF.DRW. D/A58)  
(HANDRAIL NOT SHOW FOR CLARITY)

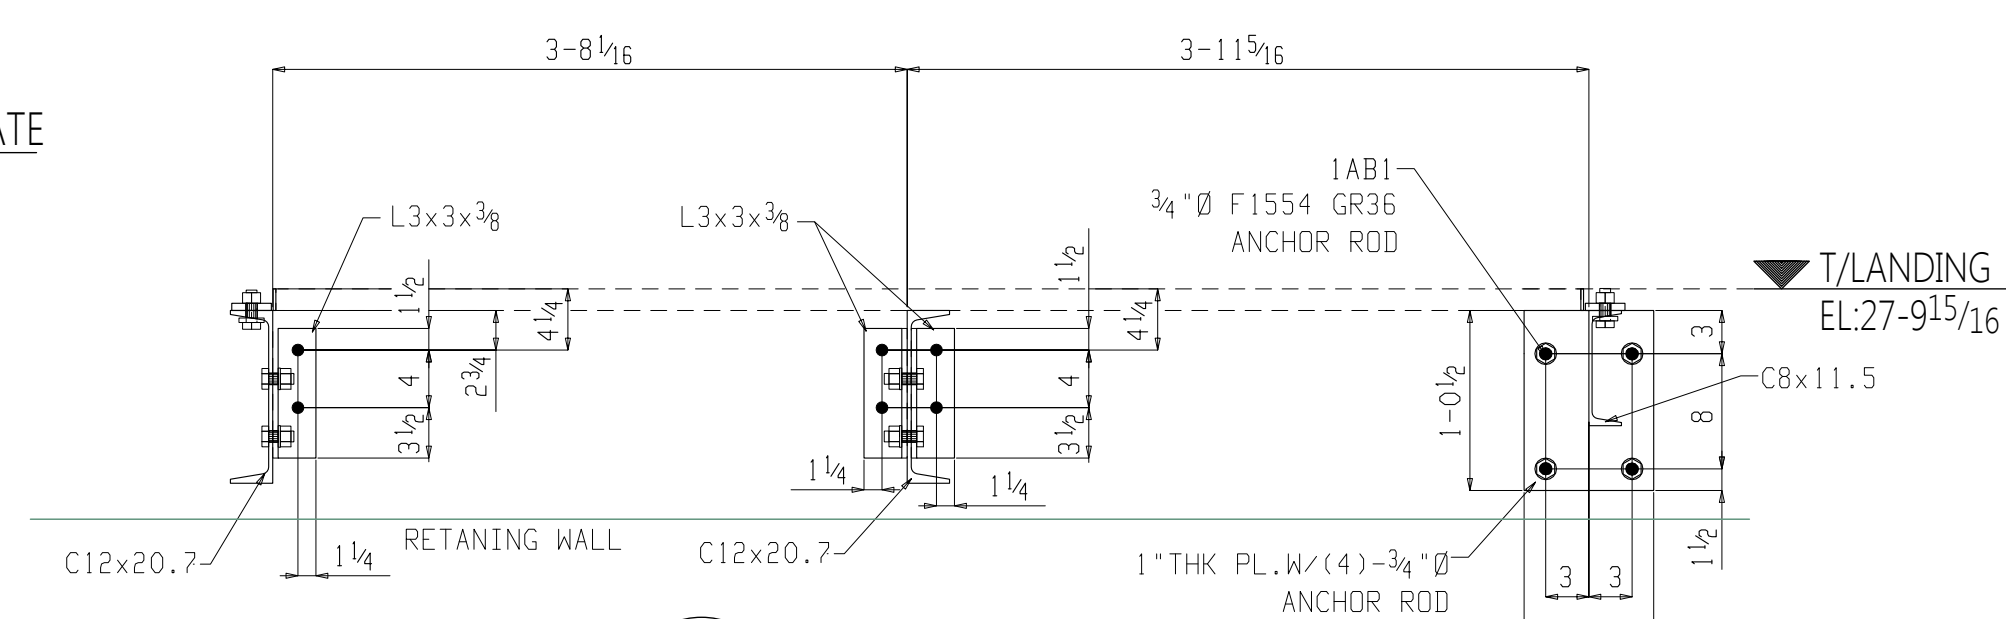
6  
E3  
SECTION VIEW  
STAIR CONNECTION TO WALL

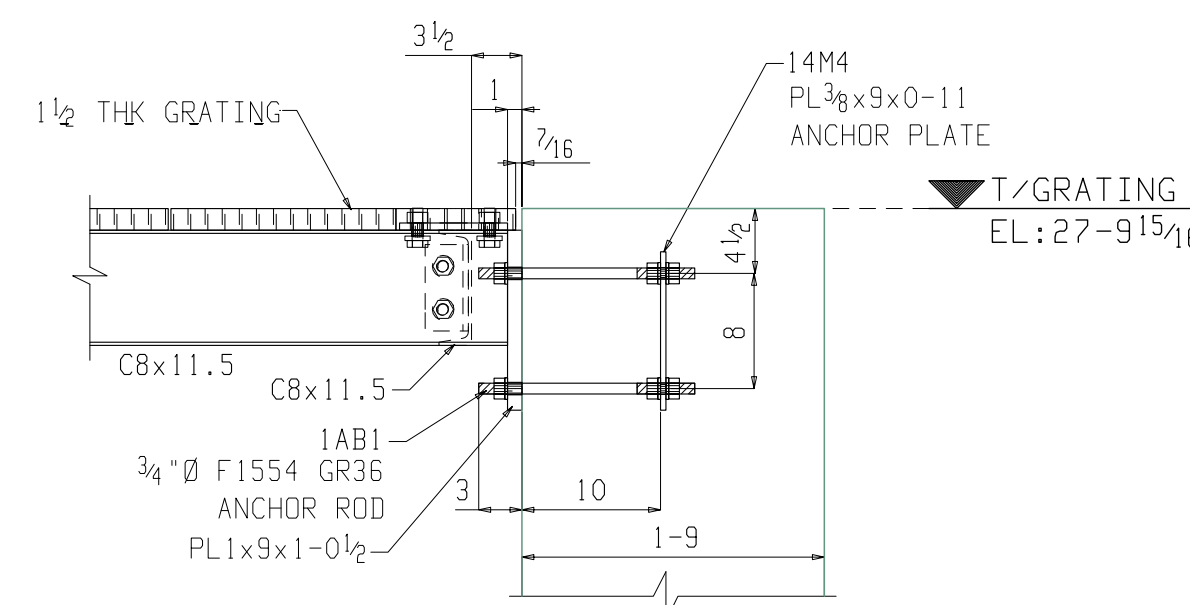
10  
E3  
SECTION VIEW  
(REF.DRW. D/A58)  
(HANDRAIL NOT SHOW FOR CLARITY)
